An MNC manufacturing health drinks packed in tetra-packs

Presence/Absence detection of date code and verification of 2D code on box on high speed conveyor

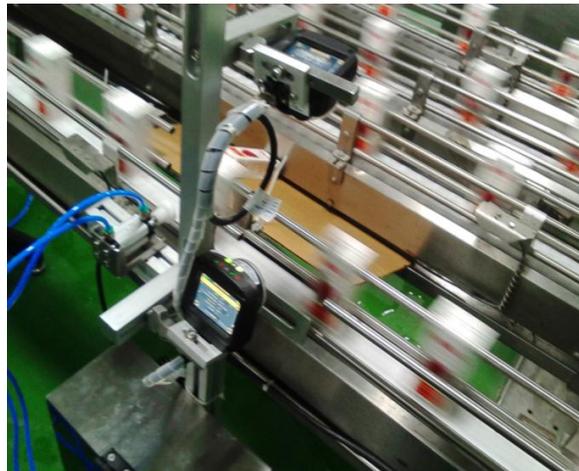
Deployed 160mm from its target, an IVu Plus TG-Gen2 with 12mm lens inspects for presence/absence detection of date code on box & Deployed 110mm from its target, an IVu Plus BCR-Gen2 with 12mm lens inspects for verification of 2D code on box.

The color of the packets for various flavours is not same. It may be any color and traveling at speeds of up to 150/minute. So we choose universal white light. Since the line is high speed, packets running very close to each other and weight such that air purge rejection will not work, we choose pneumatic pusher with smaller 50mm stroke such that the plunger returns to home position before the next packet enters its zone & thus not blocking the movement of subsequent packets.

The Epsilon IVu Plus-Gen2 TG image sensor provides a simple way to detect presence absence of date code on box using match tool. The Epsilon IVu Plus BCR-Gen2 image sensor provides a simple way to verify 2D code on box. The image of the date code is compared with the pre-saved image for each batch. In event of date code missing and wrong barcode, an electronic output is generated from Camera. In this case output is used to eject the faulty Product by pneumatic pushercylinder.
