Reliable defect detection on flanges of drum top after clamping

Detect the defects on flanges of drum top

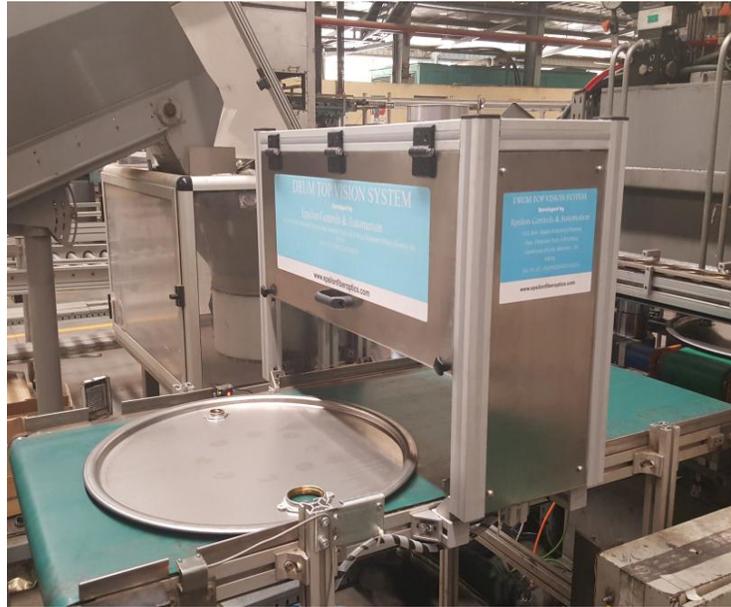
Deployed 360mm from its target, two P4-ORs with 12 and 16 mm lens respectively and white dome light inspects for defects on flanges of drum top on running conveyor

Two P4-OR camera are use for 2 inch and ¾ inch flange inspection from top with 12 and 16mm lens respectively and white dome light

The Epsilon P4-OR image sensor provides a simple way to detect defects on drum top using edge, circle detect and pattern find tools. The image of the 2 inch and ¾ inch flange is compared with the pre-Saved image for each batch. In event of a defected top one electronic output is generated from each Camera. In this case, output is used to stop the conveyor and operator manually removes the defective top.
