A large scale Automobile and Assembly industry

Reliable presence detection of small punch holes on high-capacity rotary machine

## Image Sensor Inspects & Verifies Punch holes Presence on High-Speed Rotary Machine

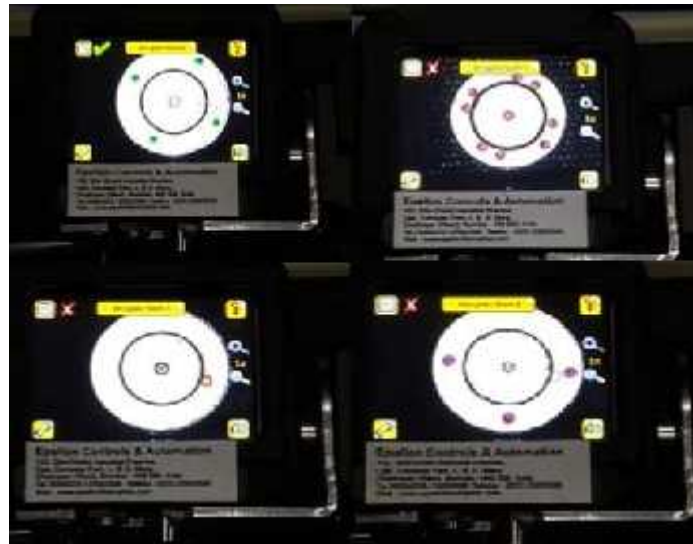
Deployed 160mm from its target, plus with 12mm lens inspect for the location and presence of Punch Holes on a high-capacity rotary Machine

To verify that the expected number of holes exist on a small metal part that is not rigidly fixed, use an iVu plus Series sensor configured for a Match application. When holes are punched, the sensor evaluates all the holes to make sure that they are present or absent. If any are not, the sensor sends a fail output to the line where the part is automatically rejected by air jet. The trick is to not teach the whole component as one pattern but to take one hole as one pattern and then count the number of patterns.
