# **Application Note...**

# Presence/Absence and verification of rubber gasket on drum closures

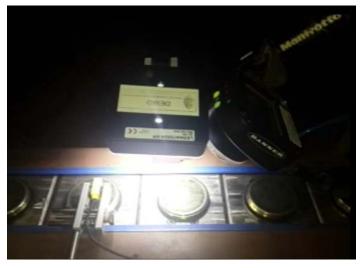
Deployed
120mm
from its target,
an iVu plus TG
with 12mm
lens inspects for
the location and
presence of, and
twist on gasket
on high speed
Conveyor.

The Epsilon iVu Plus TG image sensor provides a simple way to perform gasket verification using Area tool, Epsilon iVu plus TG sensor can provide additional reliability for Gasket. The image of the closures is compared with the pre-Saved image for each batch. In event of a missing Gasket or twisted gasket one electronic output are generated from Camera. In this case, output is used to eject the faulty Product by air purge nozzle
