Token Detection in Paint Cans

Epsilon solution

V20 vision sensor with 12mm lens & white light

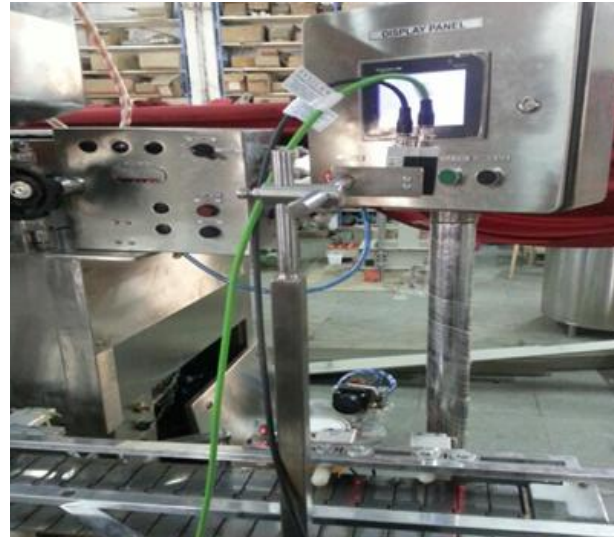
Distance from camera to conveyor = 575mm

Epsilon gives solution to reject cans without token in it with the help of V20 camera sensor. For this we use pattern matching tool in software of camera sensor by taking reference of blank can. If anything that come in blank cans and break the pattern of this blank cans like token then camera will give pass signal & if pattern is matching to blank can then it will give fail output.
